Contract #: 04-0120F4Cty: SF/ALA Rte: 80 PM: 13.2/13.9File #: 69.28**WELDING INSPECTION REPORT****Resident Engineer:**Siegenthaler, Peter**Address:** 333 Burma Road**City:** Oakland, CA 94607**Report No:** WIR-026027**Date Inspected:** 27-Jul-2011**Project Name:** SAS Superstructure**OSM Arrival Time:** 700**Prime Contractor:** American Bridge/Fluor Enterprises, a JV**OSM Departure Time:** 1900**Contractor:** Zhenhua Port Machinery Company, Ltd (ZPMC), Changxing Island **Location:** Shanghai, China

Orthotropic Box Girder (OBG) at Trial Assembly Areas

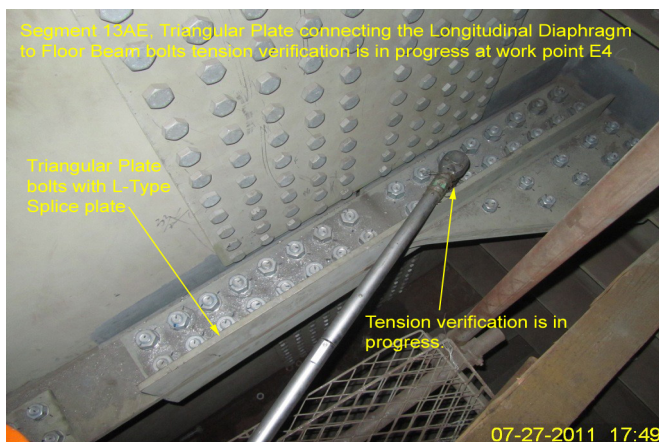
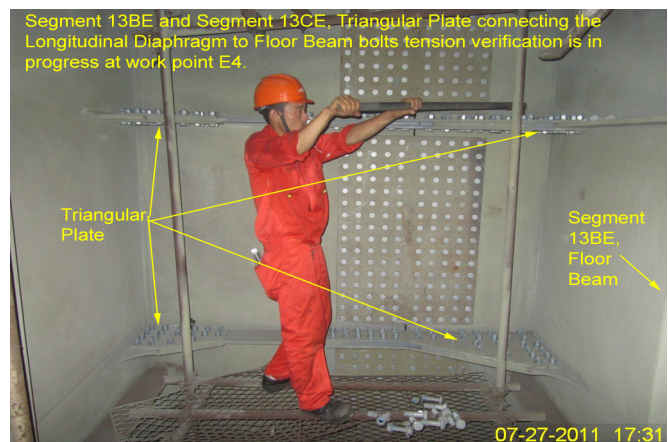
General Note: Please reference the pictures attached for more comprehensive details.
